Summary Report

Site 07GN1

Former Total Recoverable Petroleum Hydrocarbon Release

Marine Corps Air Station, El Toro, California

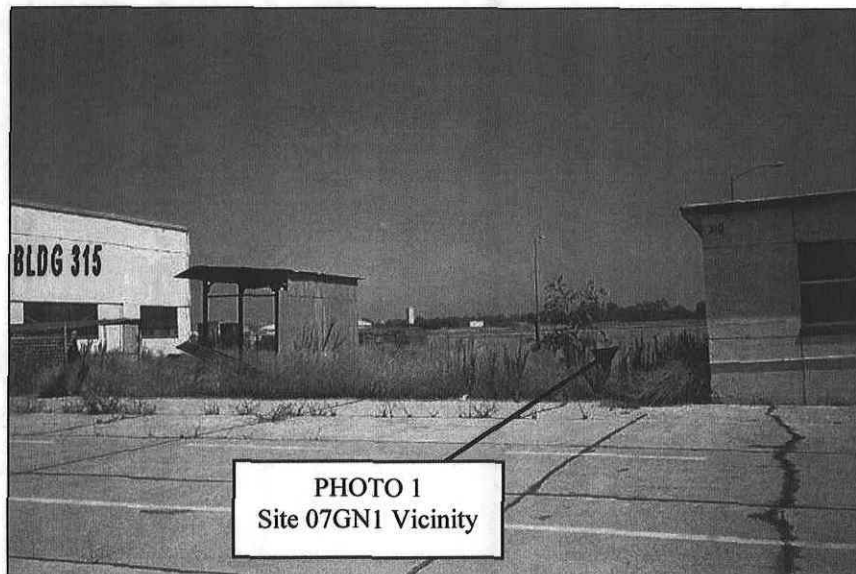
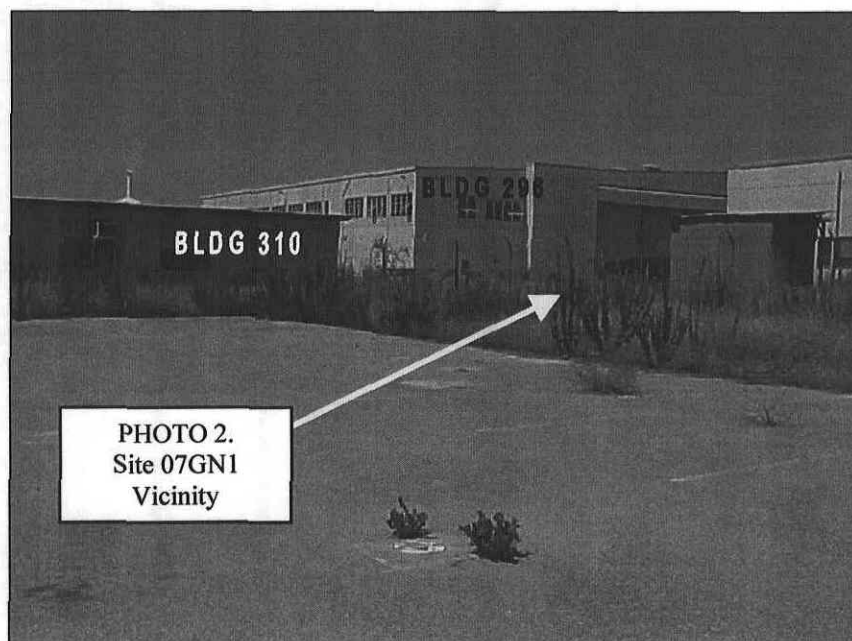
The vicinity of Site 07GN1 was visually inspected by Navy representatives in August 2001, prior to the removal of vegetation, and in September 2001, following the removal of vegetation. No evidence of petroleum hydrocarbon releases and no stained areas were observed on the ground surface. Additionally, no stains were observed on the pavement adjacent to Site 07GN1.

Photographs 1 and 2. Site 07GN1 at Installation Restoration Program (IRP) Site 7,
Unit 5 Prior to Removal of Surface Vegetation.
Marine Corps Air Station, El Toro

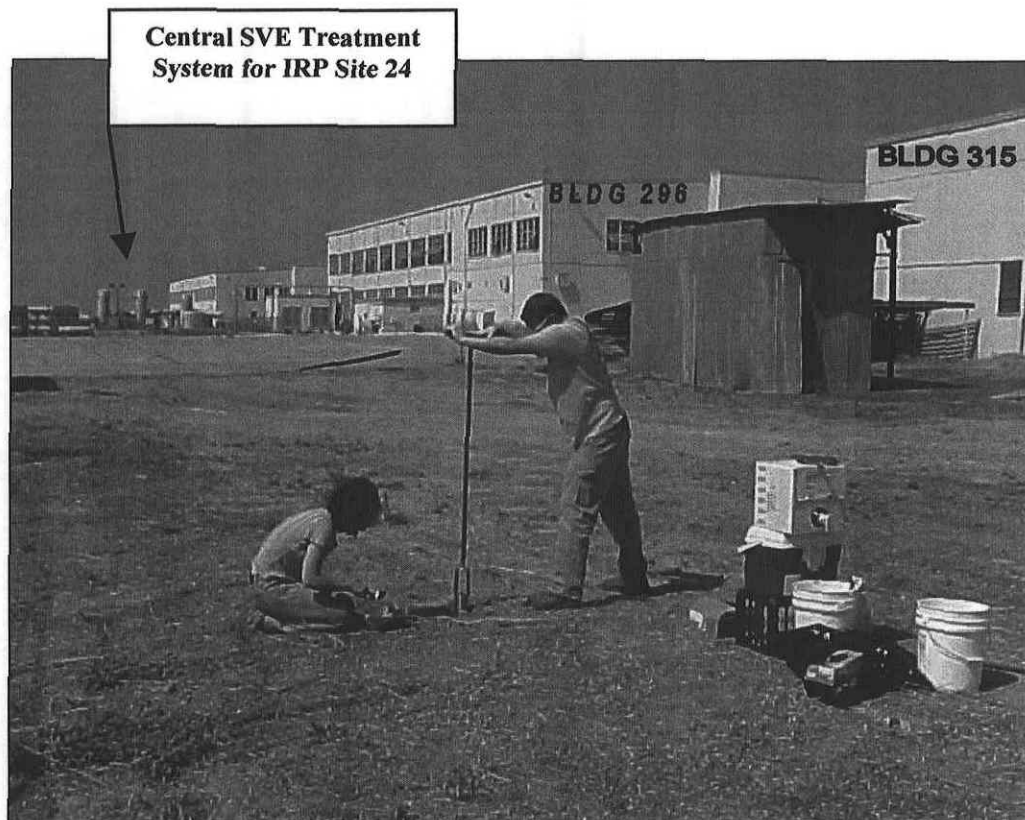
**Photograph 3. Sampling Activities at Site 07GN1
at Installation Restoration Program (IRP) Site 7, Unit , Looking Northwest Toward
IRP Site 24 SVE Treatment System.
Marine Corps Air Station, El Toro**

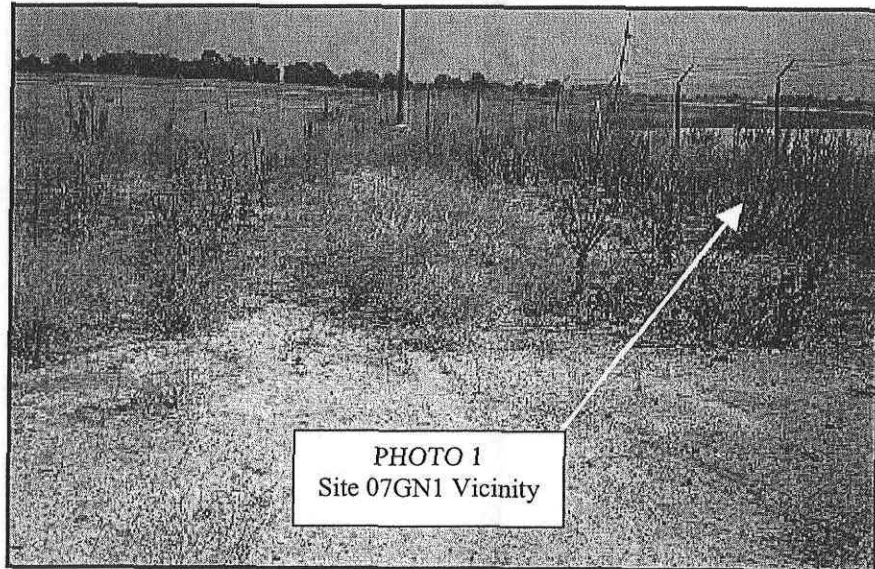
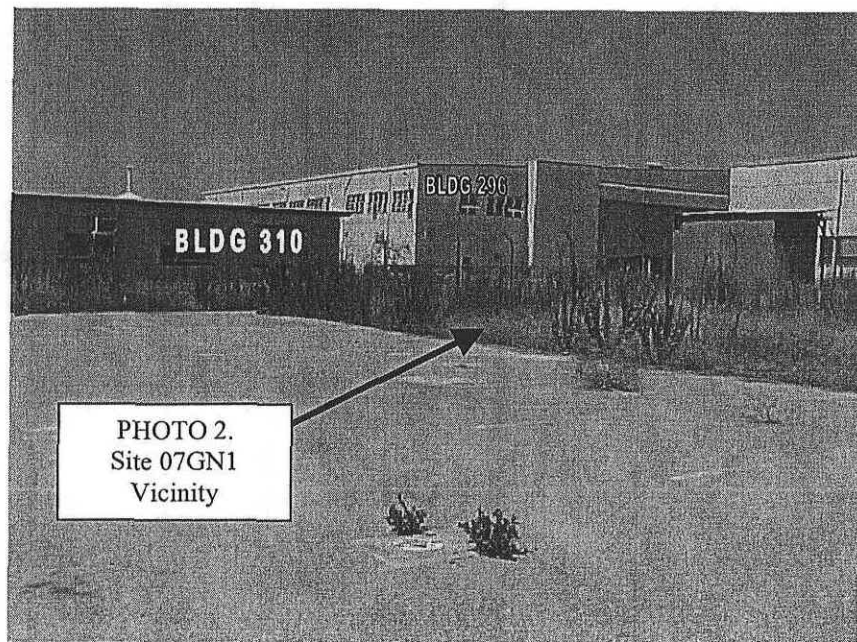
The Navy conducted visual inspections of the area between Buildings 310 and 315, and no stains or other evidence of releases was observed.

Photographs 1 and 2. Site 07GN1 at Installation Restoration Program (IRP) Site 7,
Unit 5.
Marine Corps Air Station, El Toro
